MVD Internal Review

28-Jan-2001

Technical status of MVD hardware

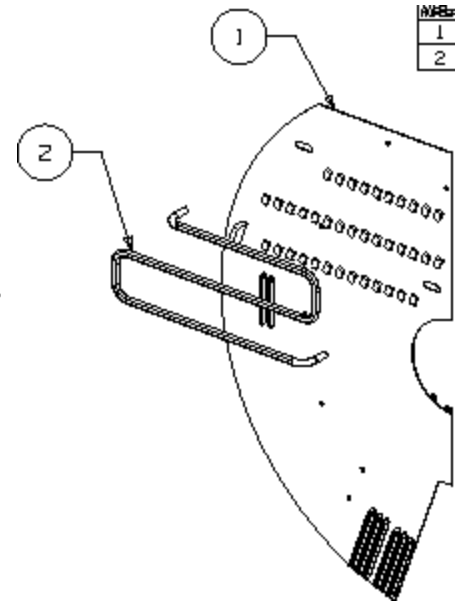
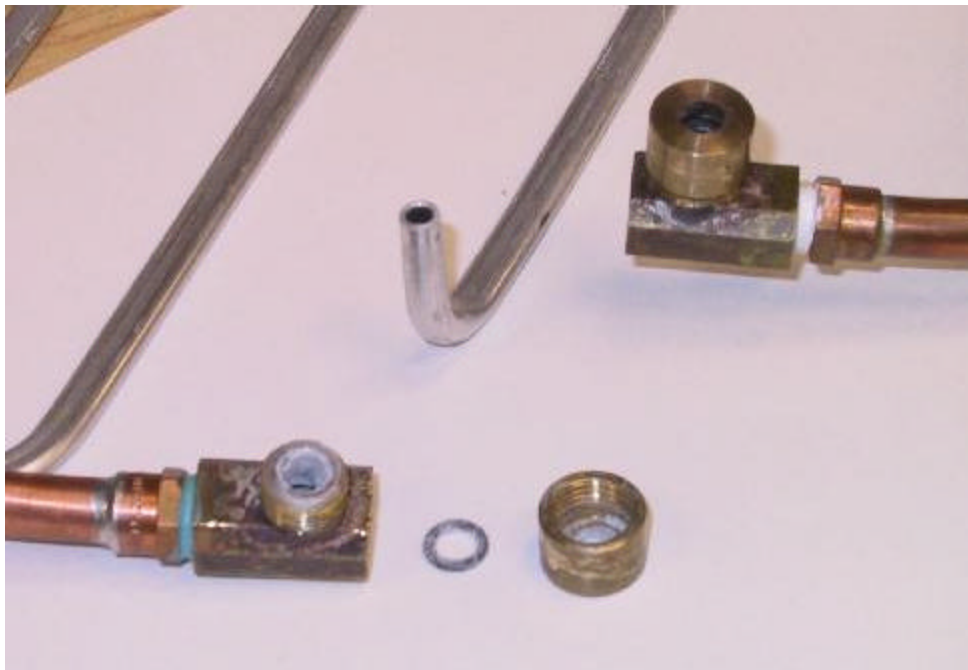
Repair cooling tubes

The cooling tubes carry water to cool voltage regulators collected on the motherboards (diagram at right). Brass fittings connect to them (below).

“Galvanic corrosion” where the brass fittings touched the Al tubes. Holes created when disconnecting the fittings.

The solution: Disassemble MVD, remove Al tubes, glue on Cu tubes. It is not conceptually hard. It will take ~2 person weeks to do this. In 1/1 previous tests, the tube came off the motherboard without problems.

Summary: We must fix this, but we know how.

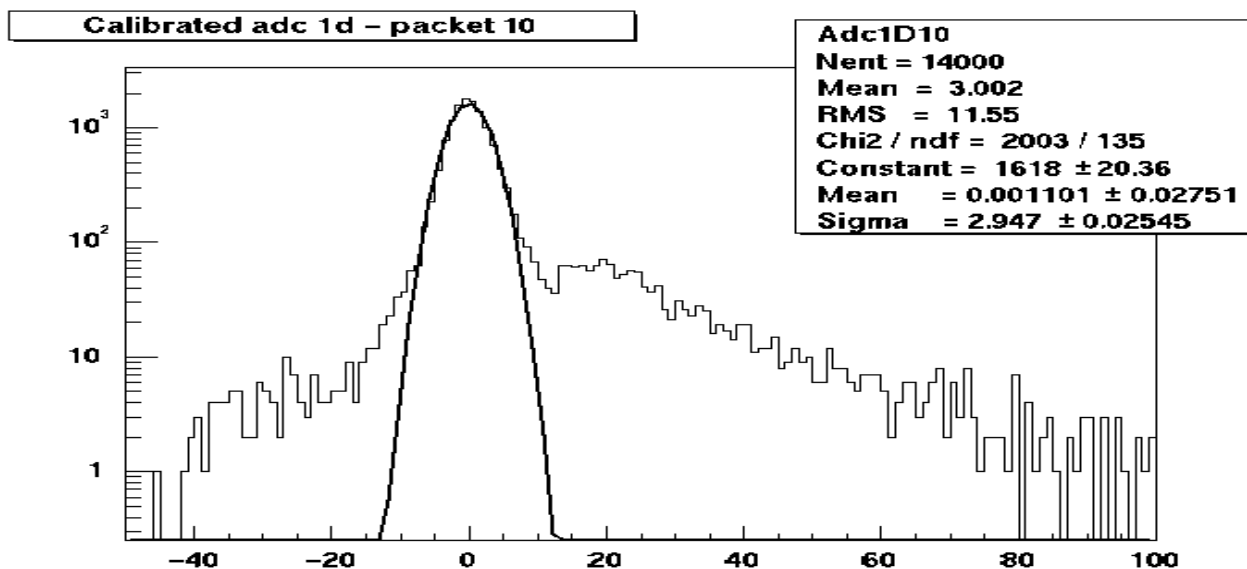
Good:

Good vs. "Poor" packet (1d)

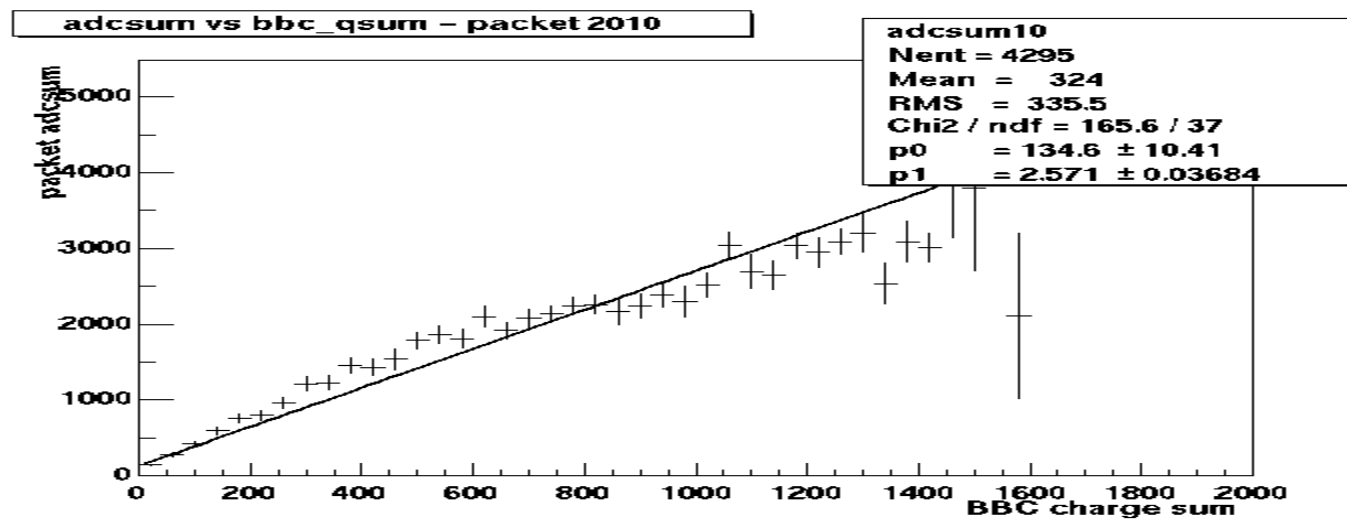
Good:
slope=
2.57

Packet ADC sum vs. BBC ADC sum

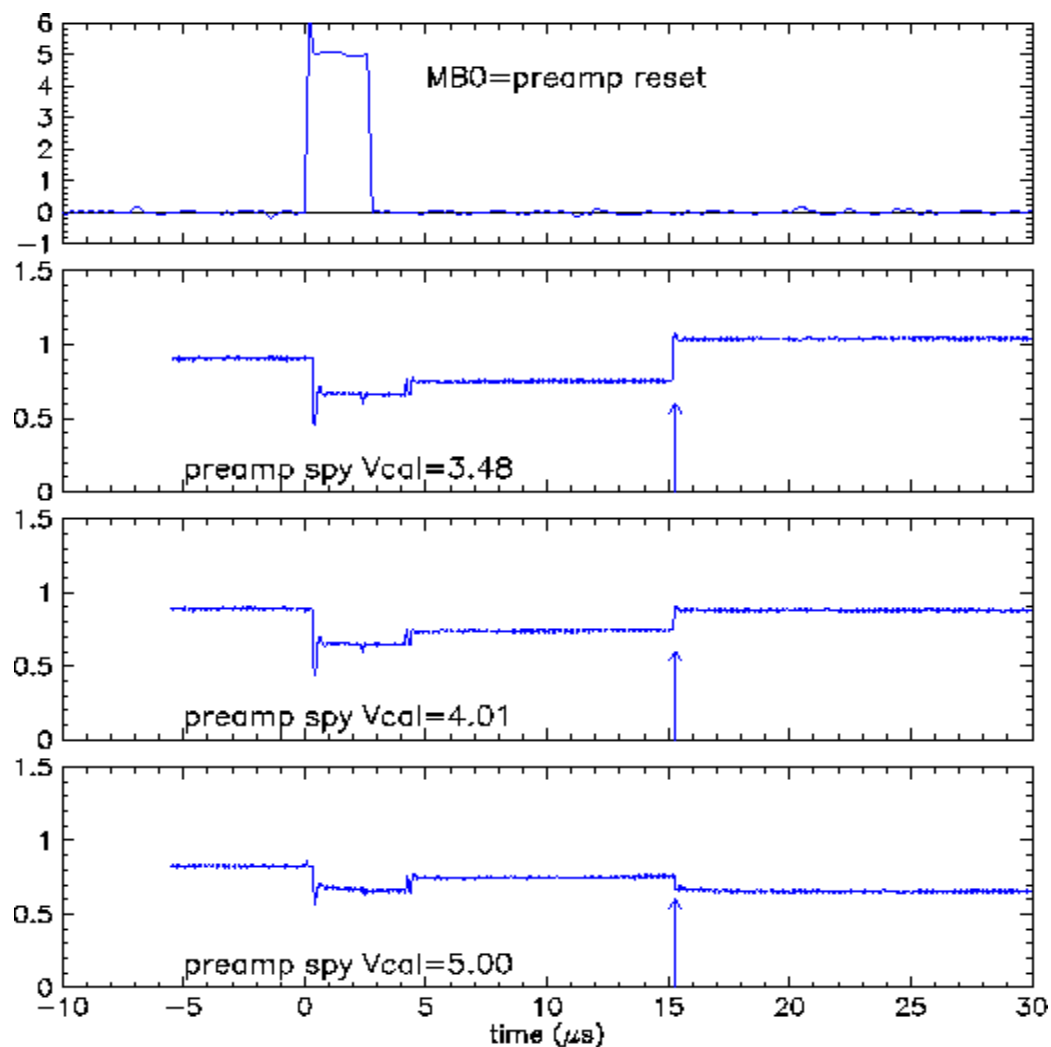
Do preamps “hit the rail”?

MCM reset and preamp signals for various injected charges:

- The rising edge, marked by the arrow, is a “hit”. The preamp needs to be reset occasionally. This is done via a mode bit command through the GTM.
- The details of the pulse shape are set via serial controls. The “Vfb” DAC can be set to give the behavior seen in the sample or to pull the signal back down to baseline.
- If the preamp signal “hits the rail”, further hits on that channels cause no change in the preamp output. The “post” - “pre” difference is digitized, but it will be zero.
- We took data runs Vfb changed from 3.0 V to 2.5 V, but have not examined the data to see if it helped.

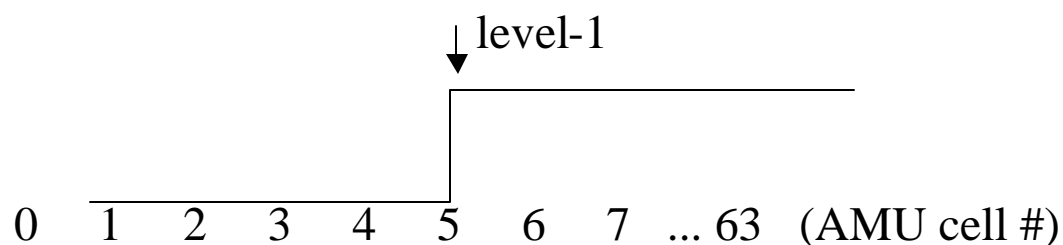
Problem with AMU cell dependent pedestal correction in pipelined mode

post - pre = 2 for first event, but cells 4 and 6 are removed from the list for ~35 us while this event is processed. In the meanwhile, the remaining 62 cells are used, so if there is a new event something like this could happen:

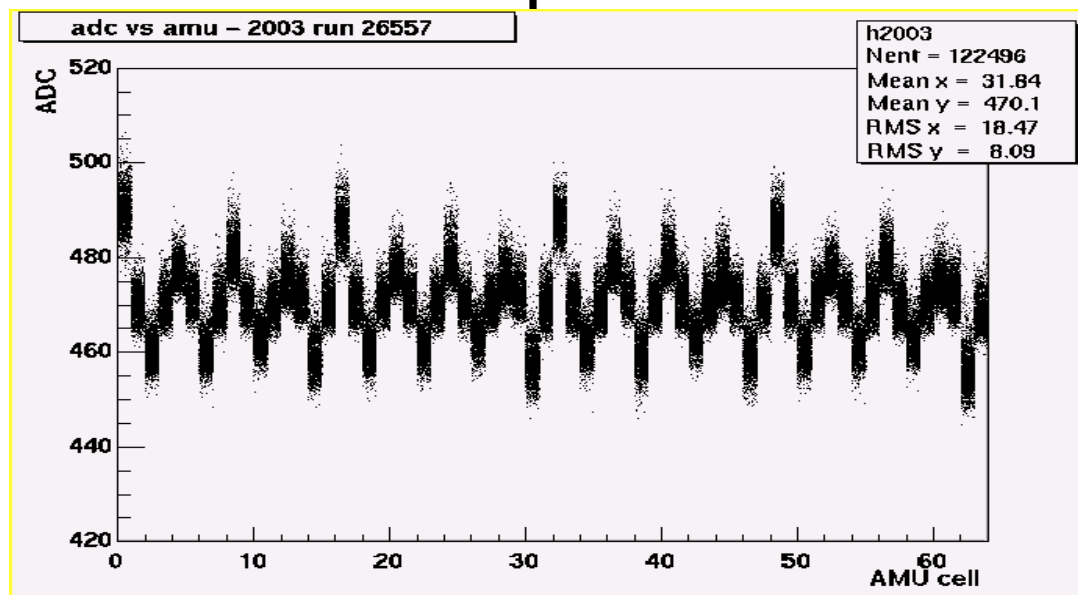
ADC value vs.
AMU cell #,
run 26557:

Pedestal drift -- AMU dependence too

The pedestal position depends on AMU cell number. The dependence varies with run number.
